ADDENDUM 01 – GENERAL

PROJECT: ENCSD Alford Hall HVAC Upgrades
PDC Project No. 22034
SCO # 22-24313-01

CAMPUS WIDE STUDY FOR
EASTERN NORTH CAROLINA SCHOOL FOR THE DEAF
WILSON, NORTH CAROLINA

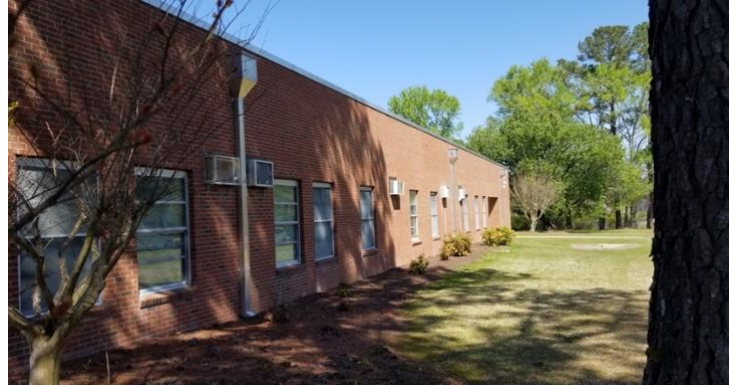
1. Low slope roof – Roof Sections A
 - a. Significant vegetative debris and growth on roof.
 - b. Minor blisters in modified bitumen membrane.
 - c. End laps in modified bitumen membrane are slipping.

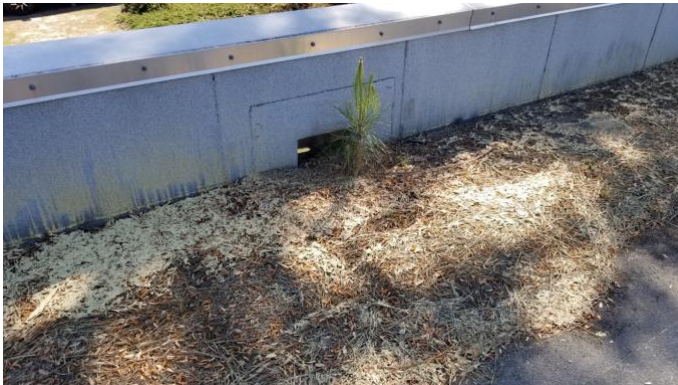
Significant debris and vegetation growing on roof

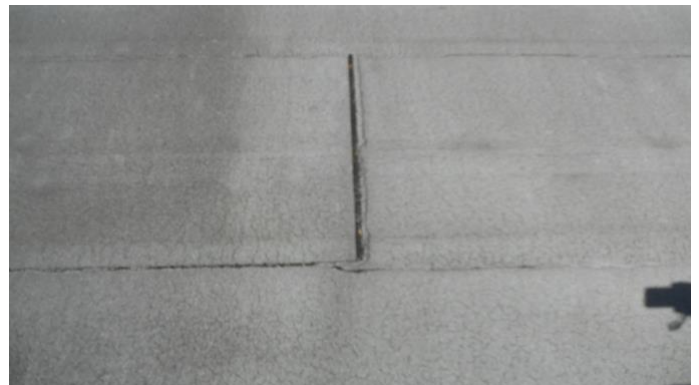
End laps in modified bitumen membrane have slipped

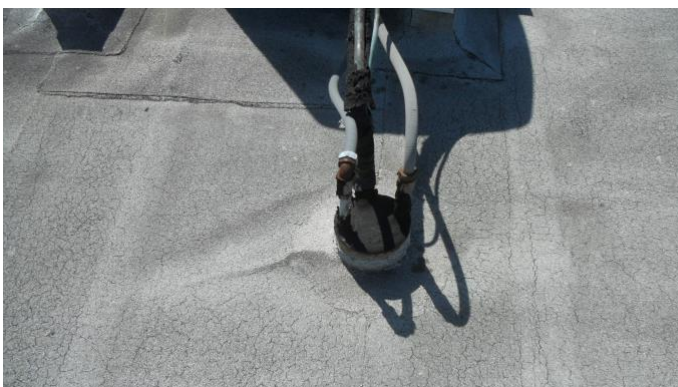
Pitch pocket requiring maintenance and minor blistering of membrane

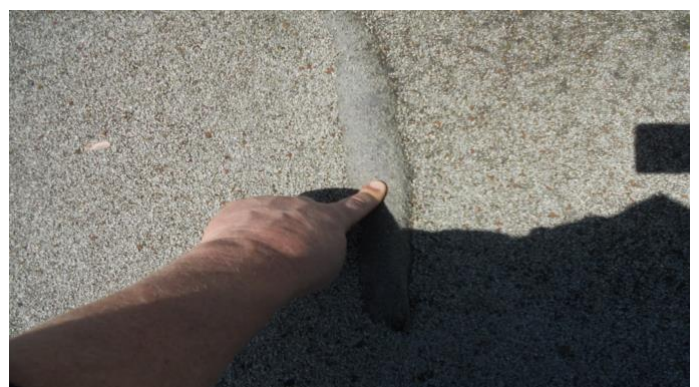
Minor blister in modified bitumen

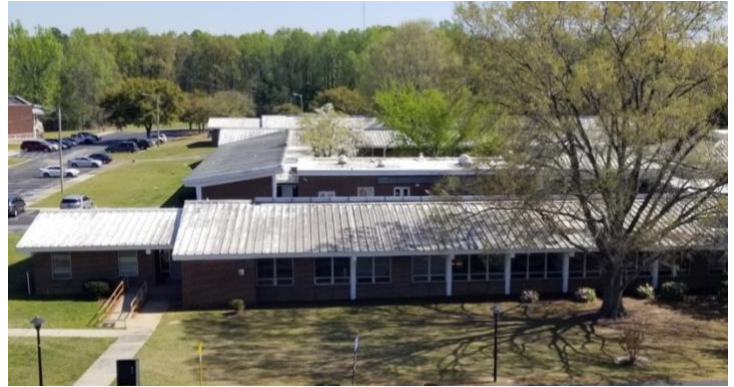
1. Structural metal panels – Roof Sections A, B, E, H and J

- a. Broken skylights.
- b. Sealant joints at end of skylights are suspect/open.

2. Low slope roofs – Roof Sections C, D, F, G and I

- a. Foam roofs with deteriorated coating and poor drainage/ponding.
- b. EPDM lined built in gutters – leaking downspout outlets causing peeling coating and some concrete spalling.
- c. Low flashing height at exhaust fan curbs.

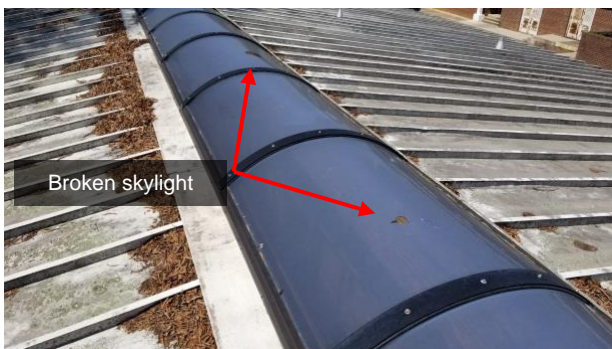
Ridge capped with domed skylight

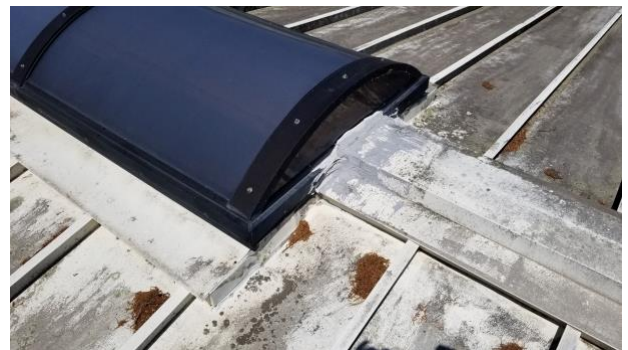
Skylight sealant joint

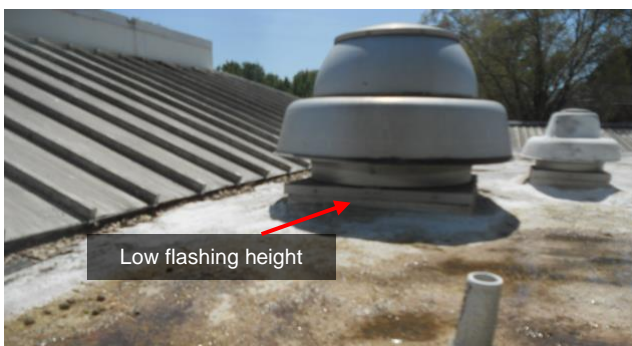
Exhaust fan curbs

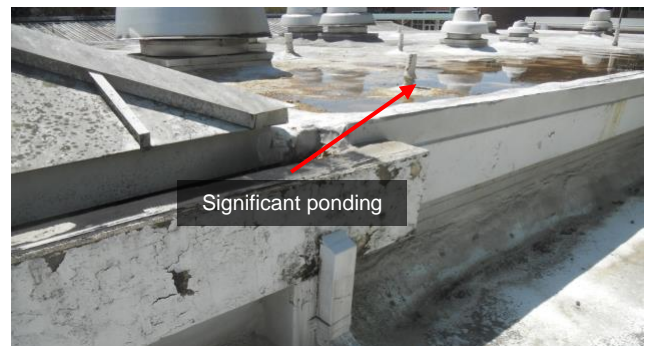
Intersection of low slope roof and steep roof

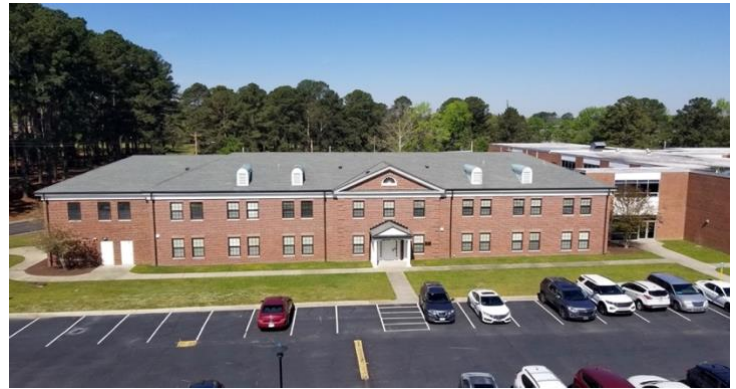
1. Steep-slope roof – Roof Sections A and B.

- a. Roof leaks at connector to Vestal Hall have been identified and repaired in recent years.

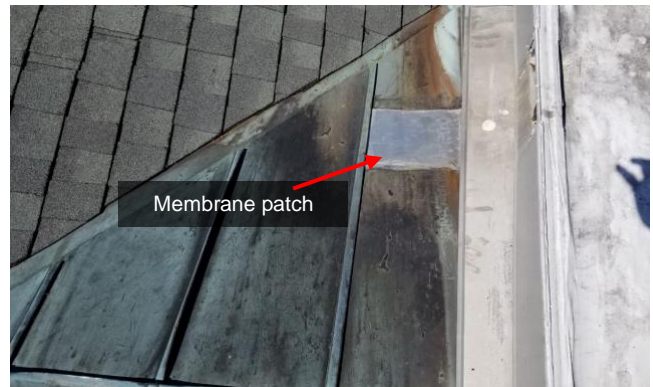
Standing seam metal roof at connector between ILC and Vestal

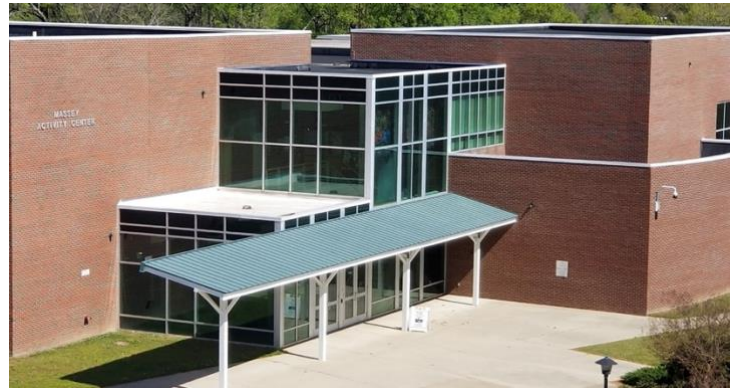
1. Low slope roof – Roof Sections A, B, C, D, E, F, and G

- a. Grease collector requiring maintenance
- b. Open coping joints
- b. Debris on roof
- d. Deteriorated membrane seams and small hole in membrane (possibly bullet hole)

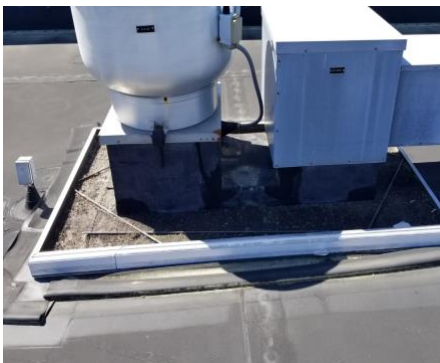
Section B – Grease collector that must be maintained

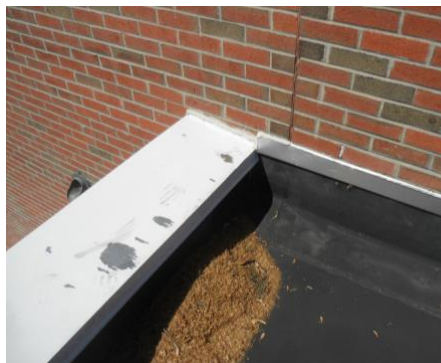
Section B – Debris on roof and peeling coping finish

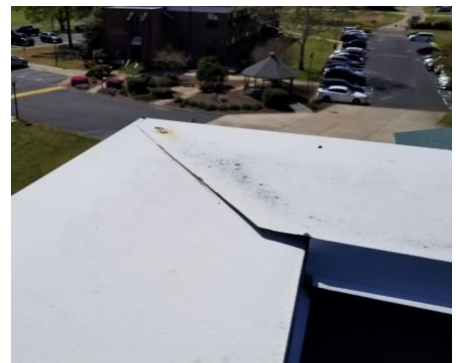
Section C – Open corner coping joint

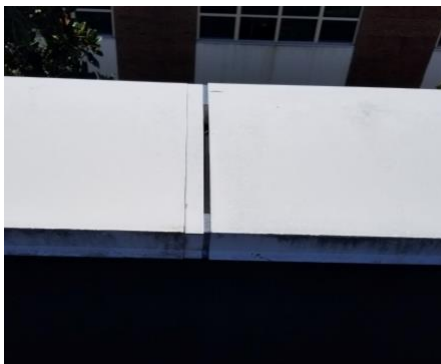
Section A – Open coping joint

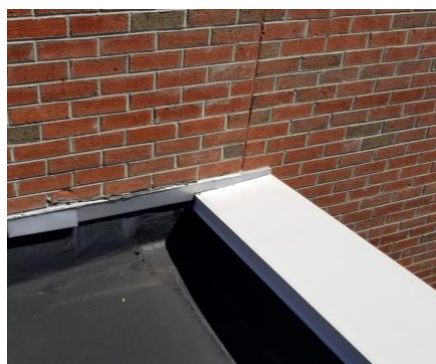
Section B – Counterflashing repair at spalled brick

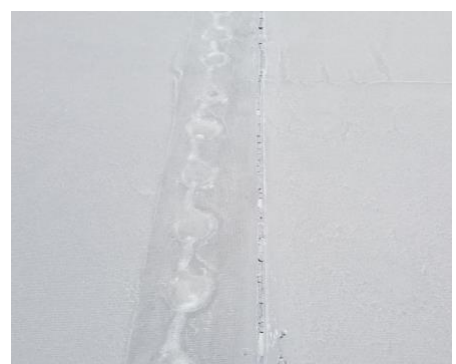
Deteriorated sealant at membrane joint

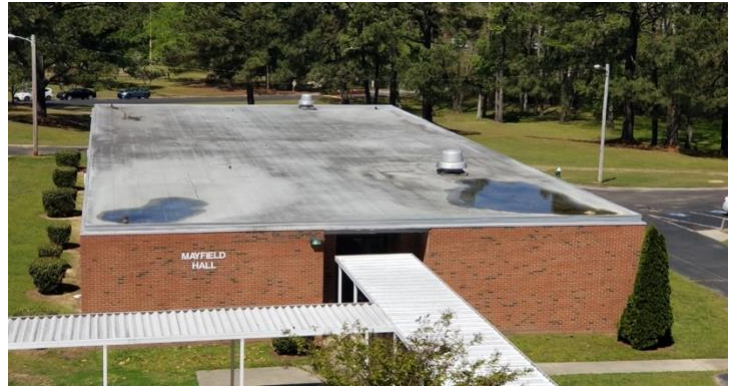
1. Low slope roof – Roof Sections A

- a. Blocked drains/ponding
- b. Low flashing heights

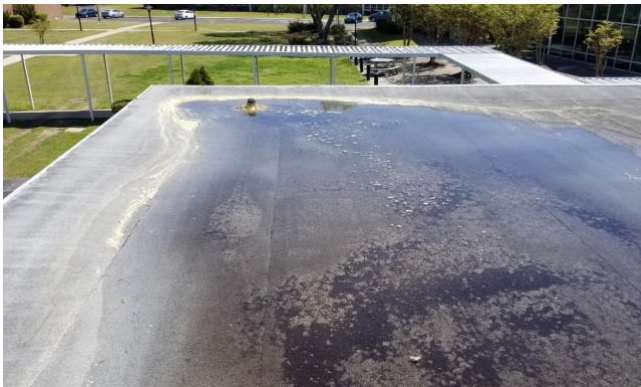
Blocked drain and significant ponding water

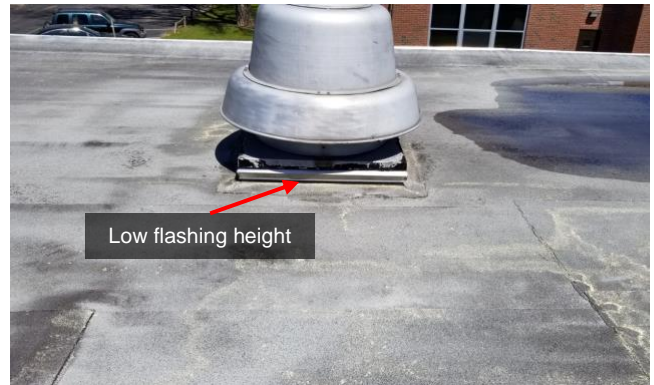
Low flashing height at exhaust fan

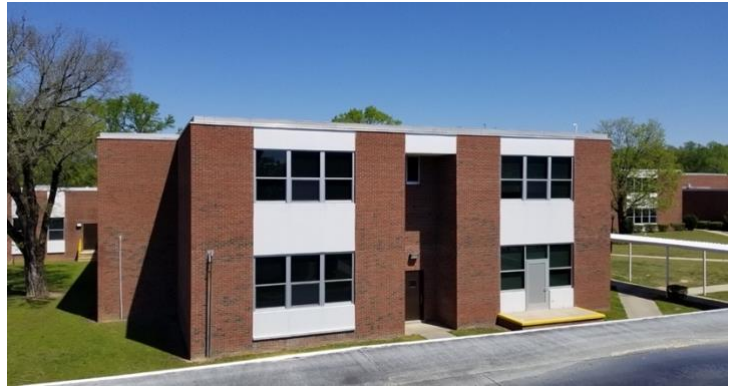
1. Gravel surfaced low slope roofing – Roof Sections A, B, C, D, E, F and G.

- a. Minor ponding – drain strainers blocked with excessive gravel
- b. Loose metal coping cap
- c. Cracked skylight domes
- d. Cracked skylight domes containing water between the domes

2. EPDM membrane low slope roofing – Roof Section H

- a. Minor ponding and failed drain target flashing
- b. Failed flashing at coping/building intersection
- c. Debris on roof
- d. Cracked masonry wall above gym and abandoned pool
- e. Broken/missing louvers

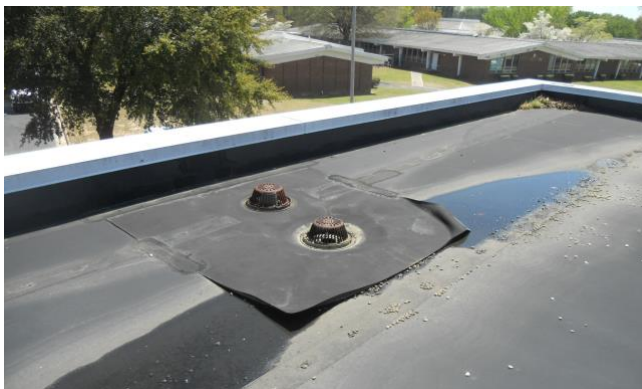
Section H – Ponding water and failed drain target sheet

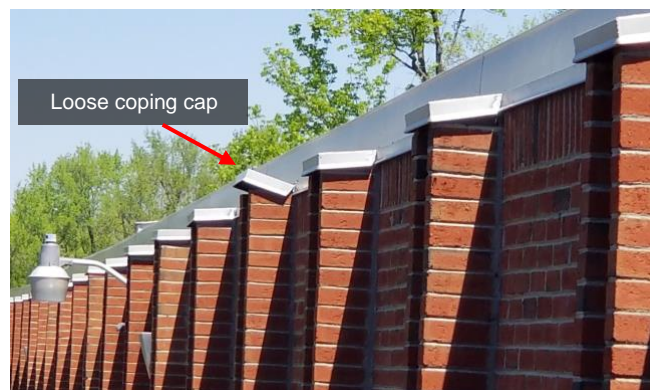
Section F – Loose sheet metal coping cap

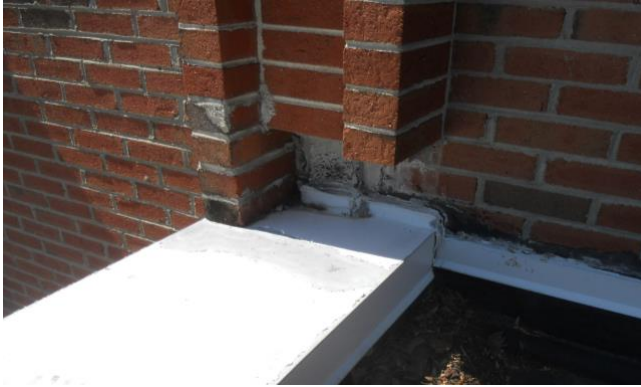
Section H – Poor coping to wall transition.

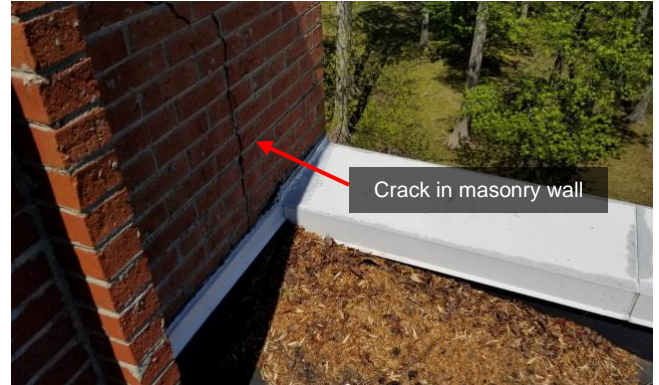
Section H –Vegetation debris on roof

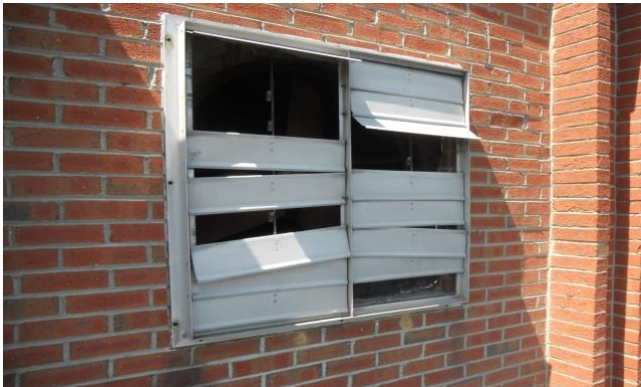
Section H – Louver slats missing can allow water intrusion at roof level

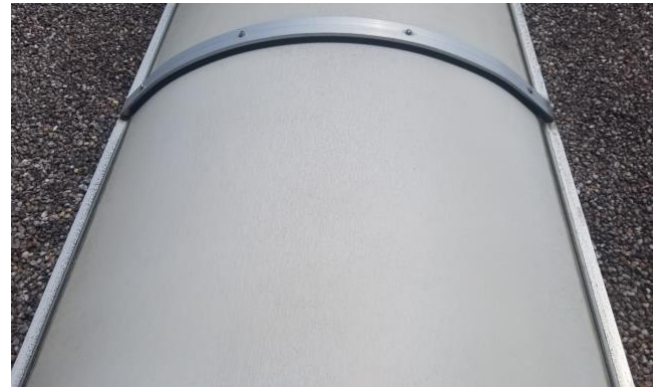
Crazed skylights

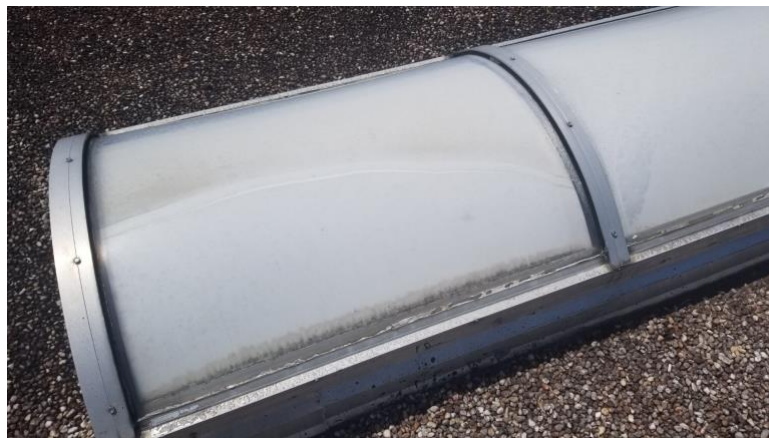
Cracked skylight with water between the domes

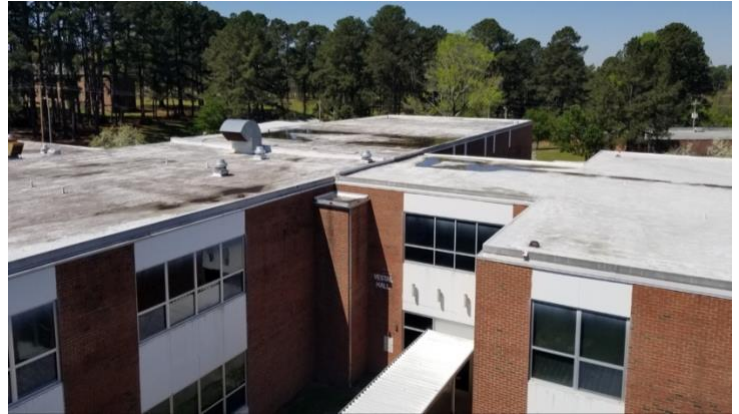
1. Low slope roof – Roof Sections A, B, C, D, E, F, G and H

- a. Blocked drains/ponding
- b. Deteriorated coating
- c. Small elevator shaft membrane roof loose, wrinkled

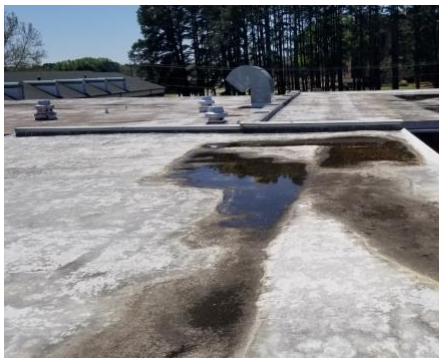
Drainage issues and ponding –
Sections E and F

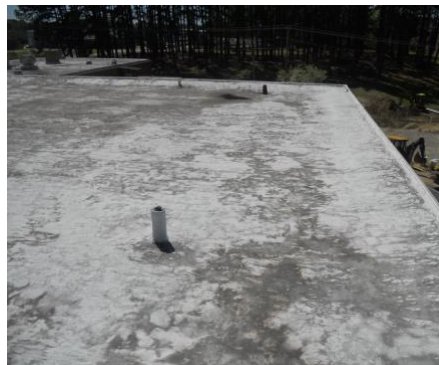
Coating in poor condition –
Section E

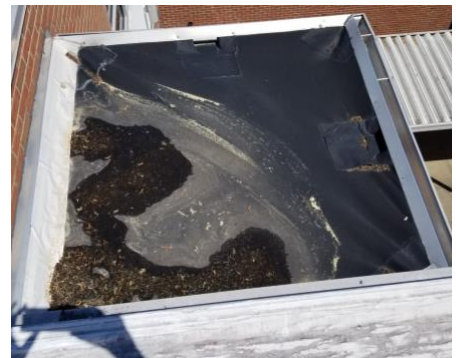
Section H in poor condition

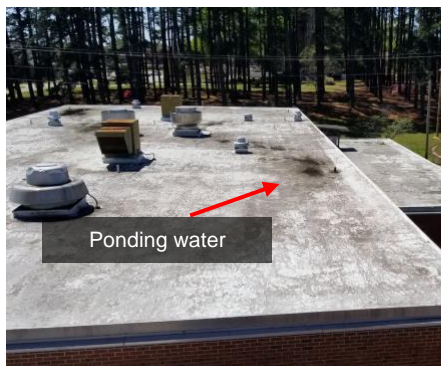
Ponding water and poor coating
condition – Sections A & C

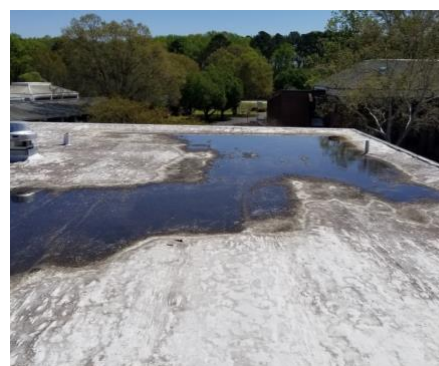
Ponding water on Section F
