Pre-Bid Agenda, Sign-in Sheet and ENCSD Campus Roof Report

PDC PROJECT NO. 22035 EASTERN NORTH CAROLINA SCHOOL FOR THE DEAF – MAYFIELD HALL HVAC PRE-BID CONFERENCE MEETING MINUTES JUNE 26, 2023 AT 10:30AM

CAMPUS WIDE STUDY FOR EASTERN NORTH CAROLINA SCHOOL FOR THE DEAF

WILSON, NORTH CAROLINA

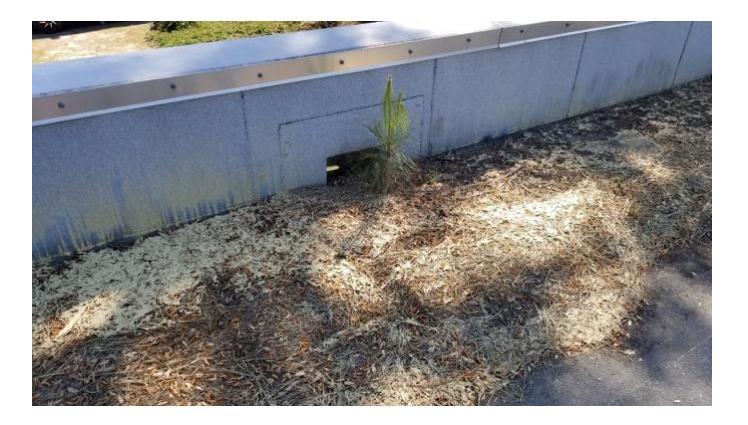
Significant debris and vegetation growing on roof

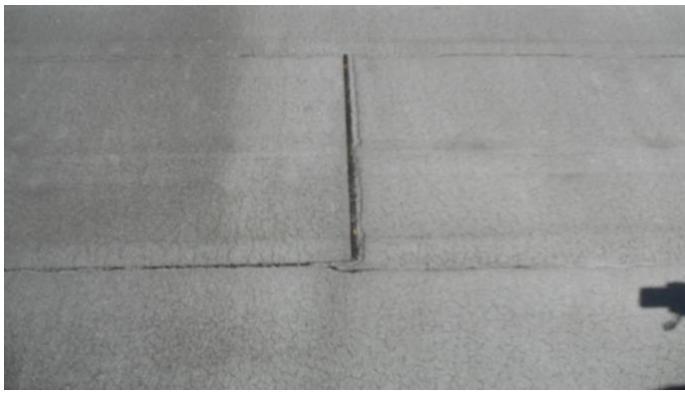
End laps in modified bitumen membrane have slipped

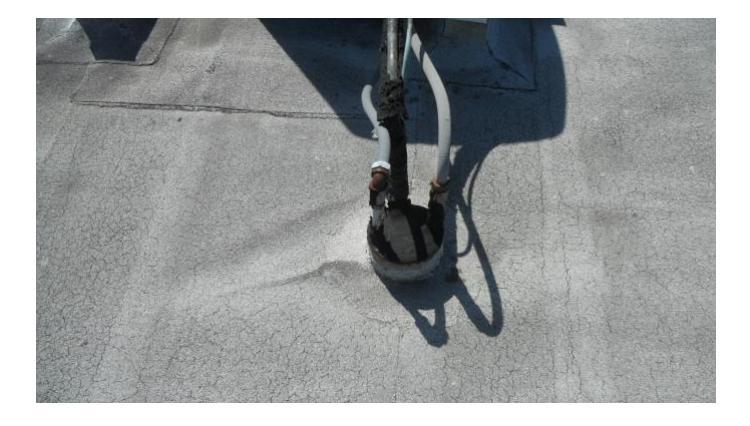
Pitch pocket requiring maintenance and minor blistering of membrane

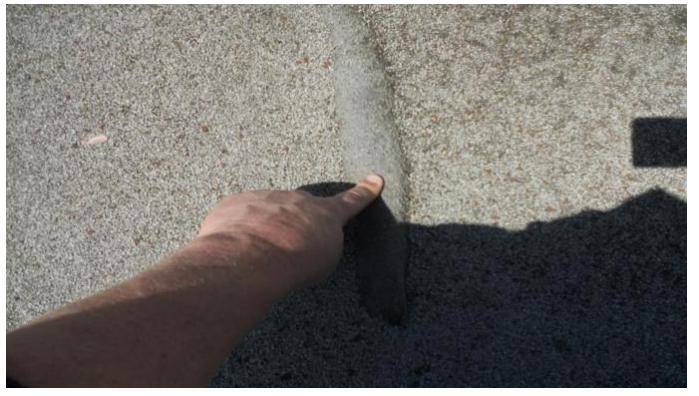
Minor blister in modified bitumen

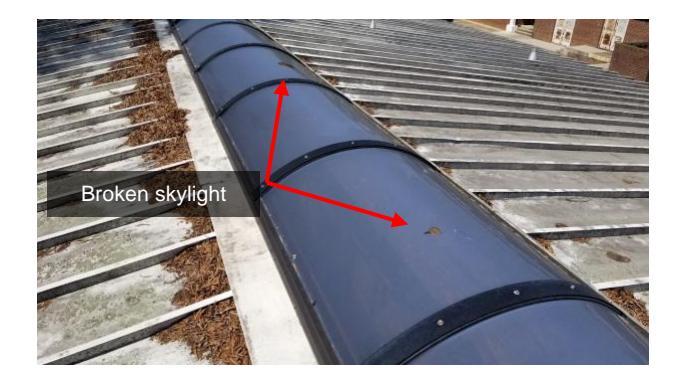
Ridge capped with domed skylight

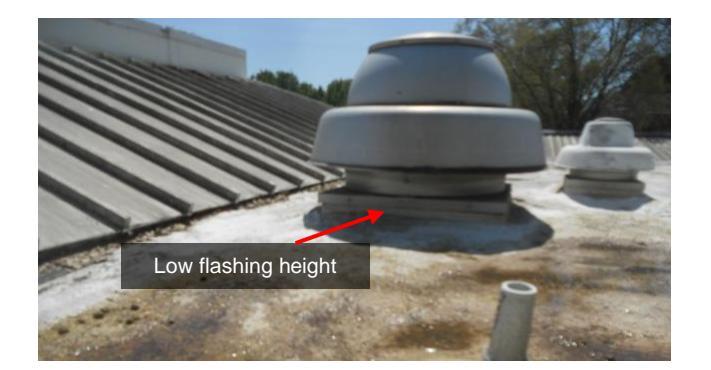
Exhaust fan curbs

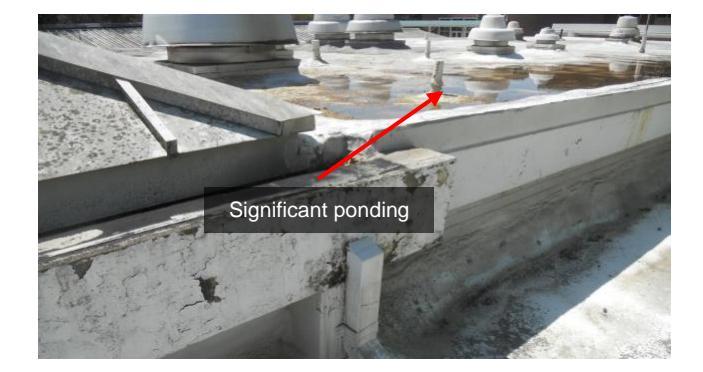
Intersection of low slope roof and steep roof

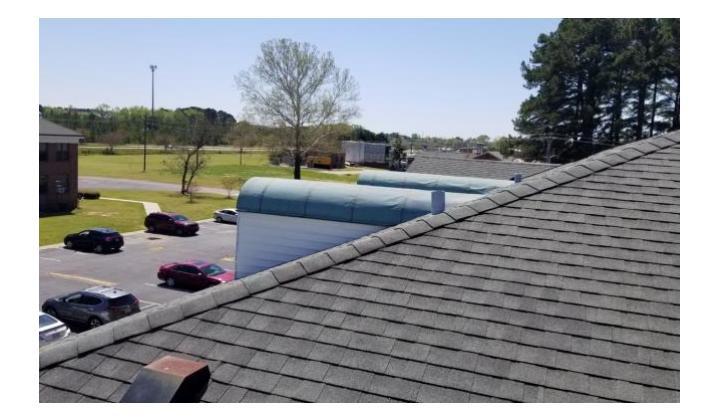
Asphalt / fiberglass shingles and copper topped dormer / louvers

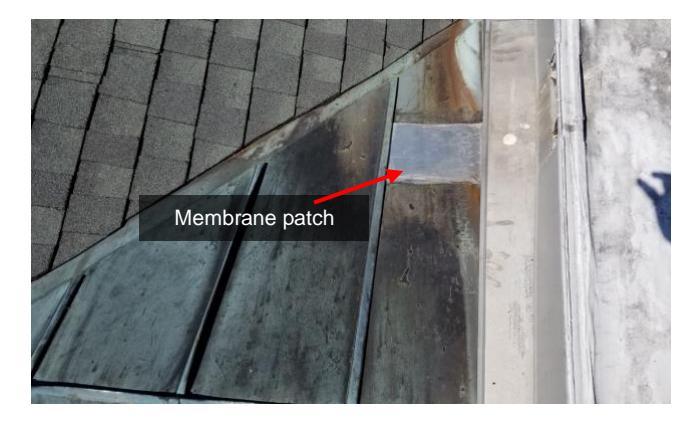
Standing seam metal roof at connector between ILC and Vestal

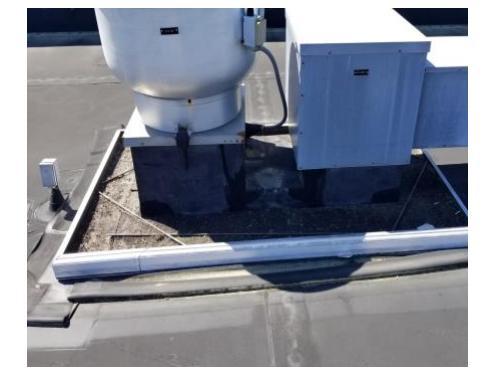
Section B – Grease collector that must be maintained

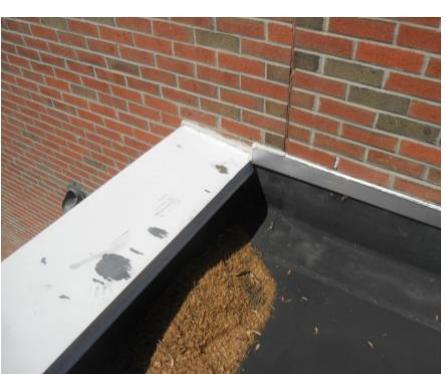
Section B – Debris on roof and peeling coping finish

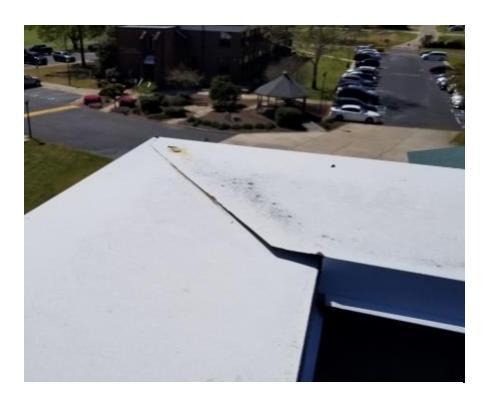
Section C – Open corner coping joint

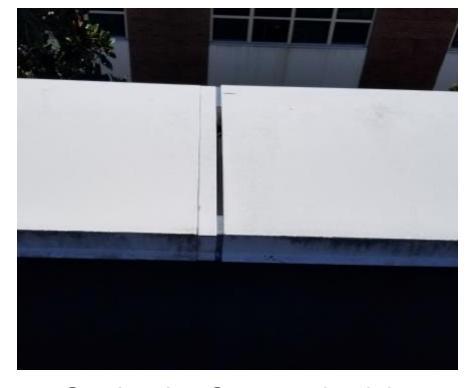
Section A – Open coping joint

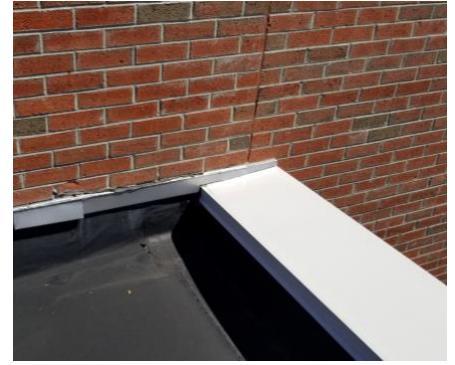
Section B – Counterflashing repair at spalled brick

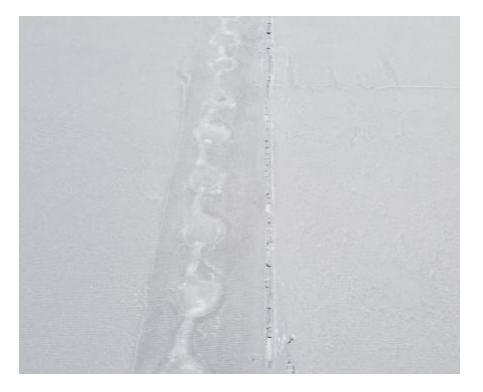
Deteriorated sealant at membrane joint

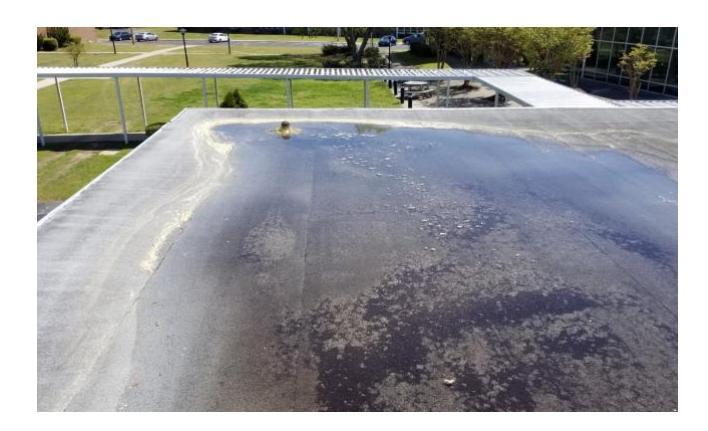
Blocked drain and significant ponding water

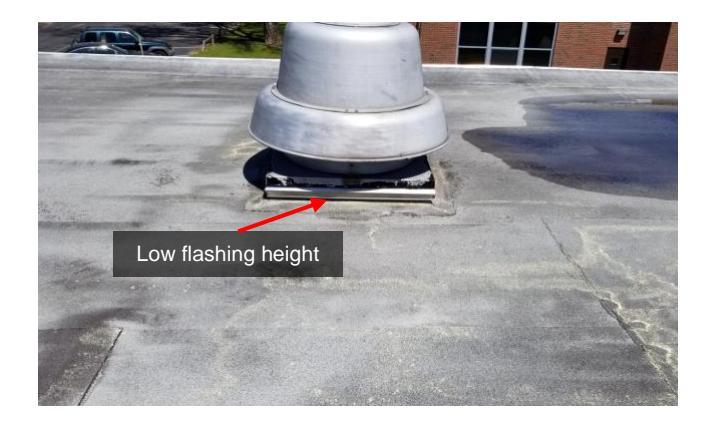
Low flashing height at exhaust fan

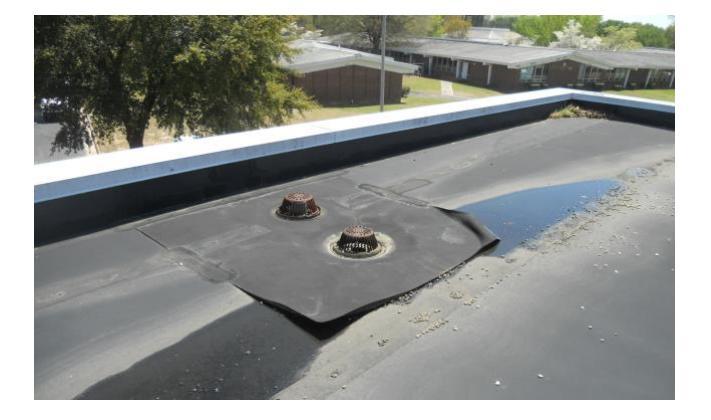
Section H – Ponding water and failed drain target sheet

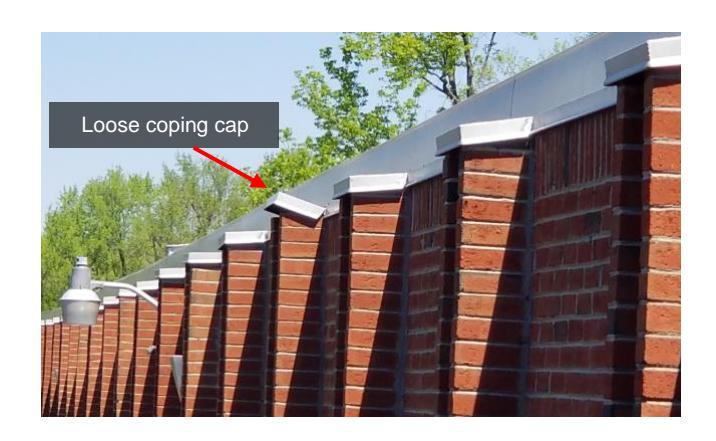
Section F - Loose sheet metal coping cap

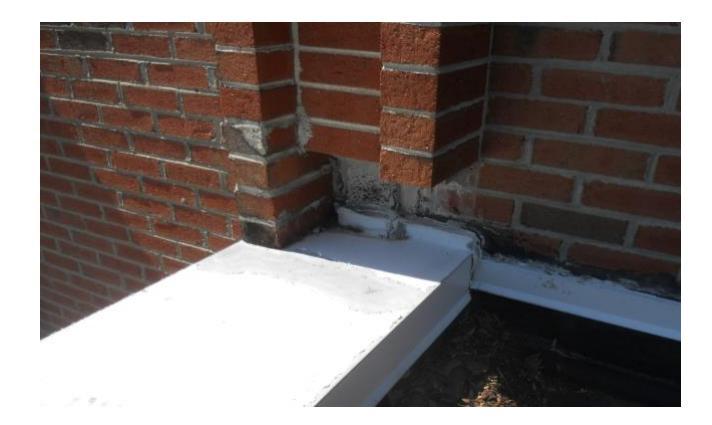
Section H – Poor coping to wall transition.

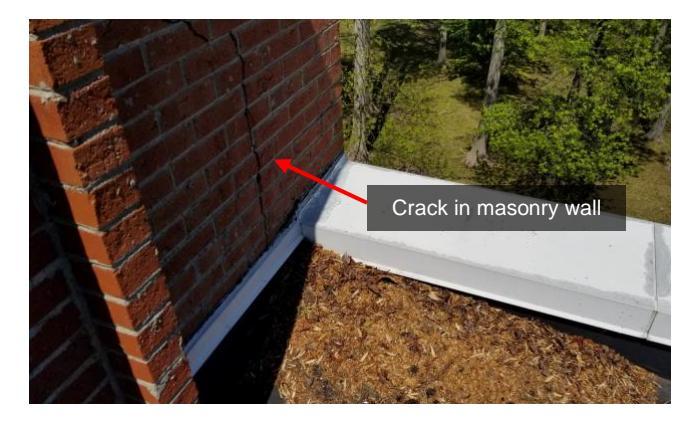
Section H-Vegetation debris on roof

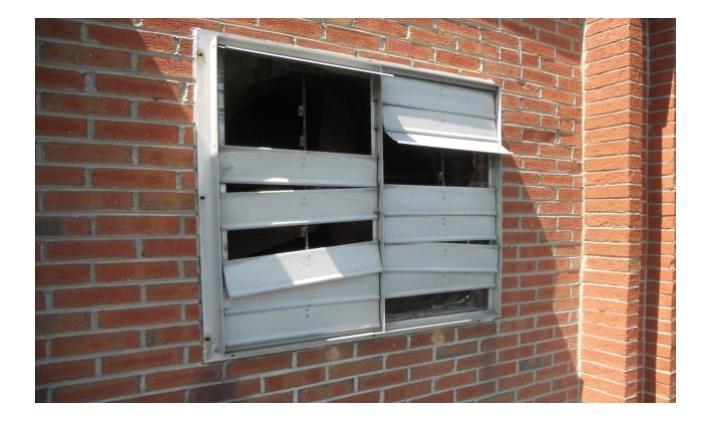
Section H – Louver slats missing can allow water intrusion at roof level

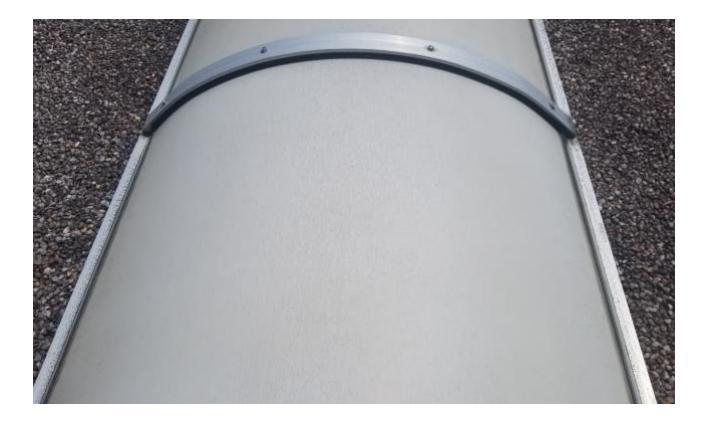
Crazed skylights

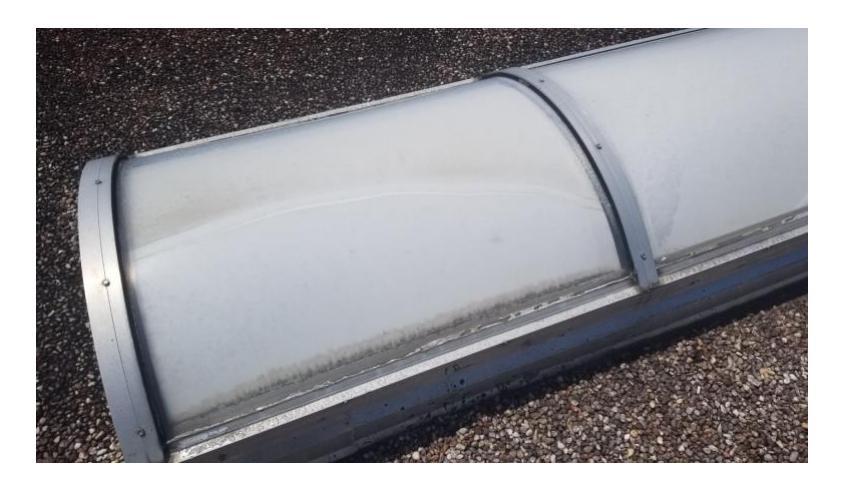
Cracked skylight with water between the domes

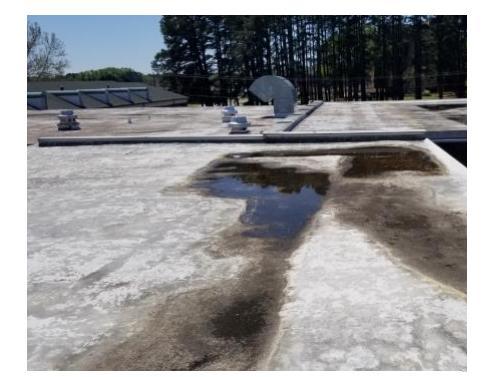
Drainage issues and ponding – Sections E and F

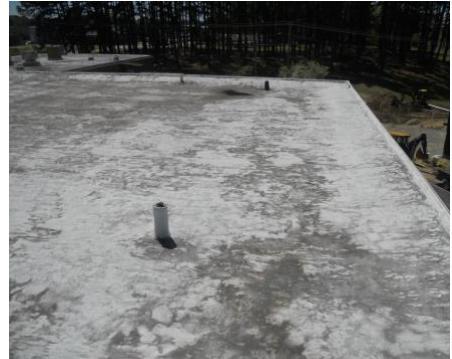
Coating in poor condition – Section E

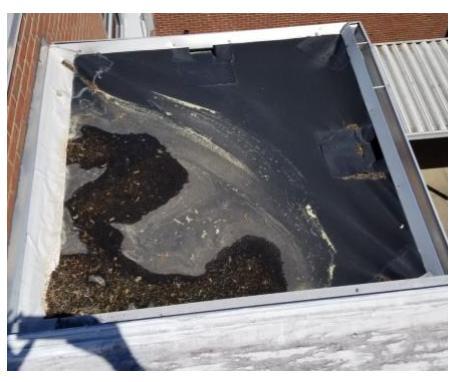
Section H in poor condition

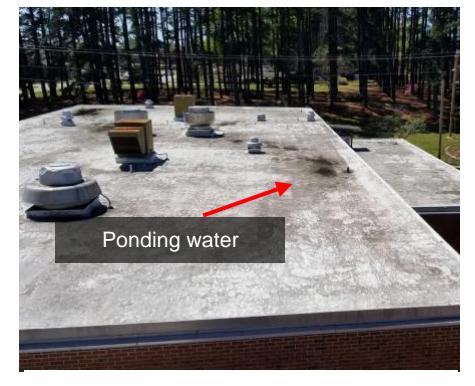
Ponding water and poor coating condition – Sections A & C

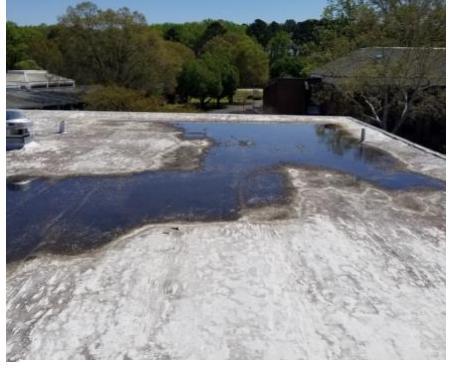
Ponding water on Section F

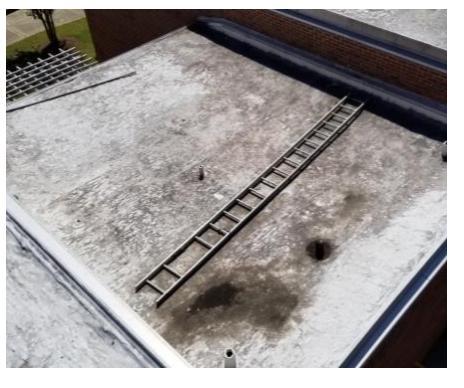
Connector roof D between Sections A and E.
