Pre-Bid Agenda, Sign-in Sheet and ENCSD Campus Roof Report

PDC PROJECT NO. 22035 EASTERN NORTH CAROLINA SCHOOL FOR THE DEAF – MAYFIELD HALL HVAC PRE-BID CONFERENCE MEETING MINUTES JUNE 26, 2023 AT 10:30AM

CAMPUS WIDE STUDY FOR EASTERN NORTH CAROLINA SCHOOL FOR THE DEAF

WILSON, NORTH CAROLINA

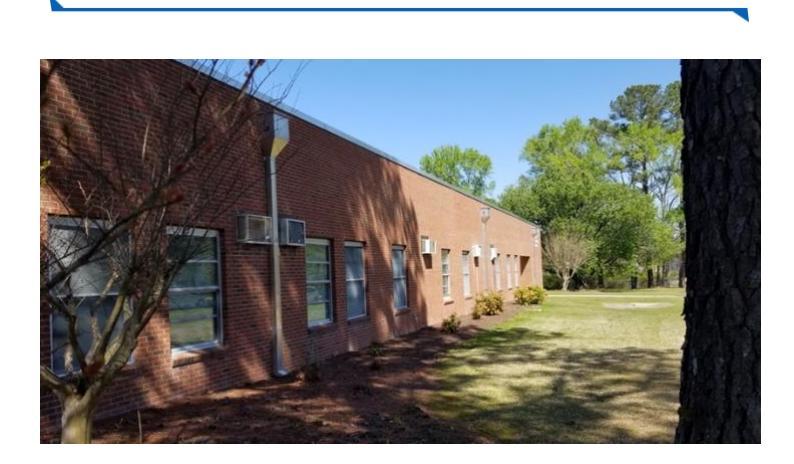
Alford Hall

Alford hall is a single-story classroom building with vocational shops along the back side of the building and under a metal roof canopy. The perimeter of the building has a parapet varying from approximately 12 inches to 28 inches high. A modified bitumen membrane is in overall good condition with minor deficiencies noted.

- 1. Low slope roof Roof Sections A
 - a. Significant vegetative debris and growth on roof.
 - b. Minor blisters in modified bitumen membrane.
 - c. End laps in modified bitumen membrane are slipping.

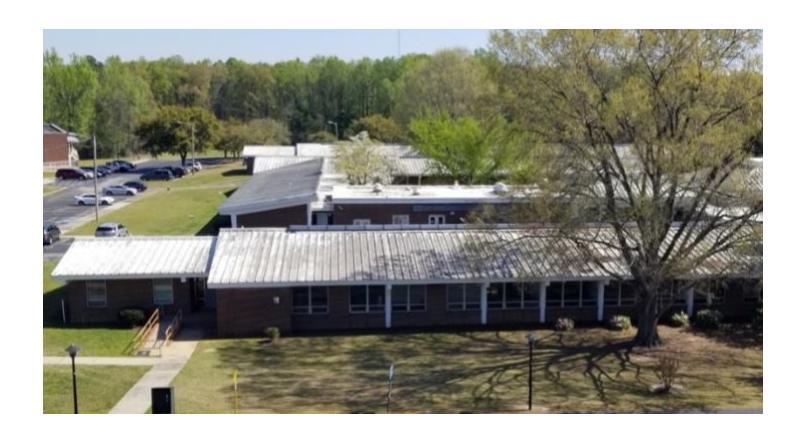
Eagles Hall

This is a large single-story, multi-wing classroom building with the majority of the roof covered with structural standing seam metal panel roofs. The ridge of the metal panels is capped with curved dome skylights. Smaller low slope roof sections have been sprayed with foam and coated. Building is currently undergoing an overall building assessment and roof replacement assessment.

1. Structural metal panels - Roof Sections A, B, E, H and J

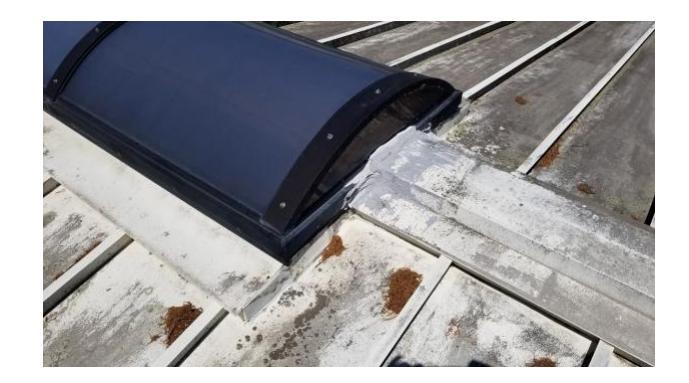
Exhaust fan curbs

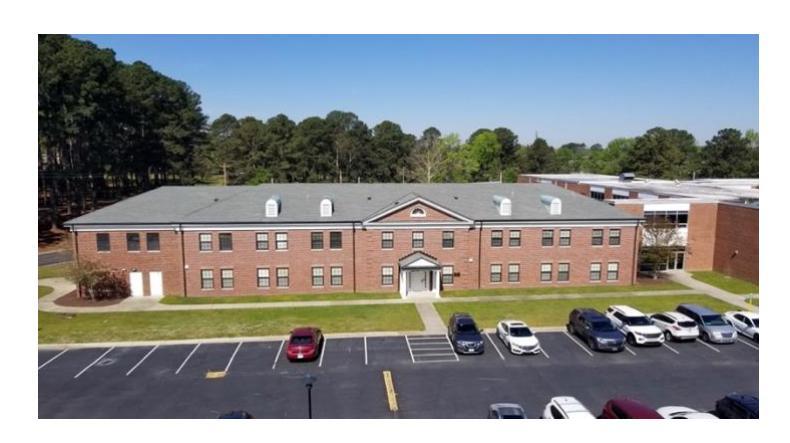
ILC Building

This building is a two-story administrative building with steep-slope roofs and asphalt/fiberglass shingles. Drainage is by perimeter gutters and downspouts. This building is connected to Vestal Hall with a low slope roof that is considered part of Vestal Hall. The roof transition between ILC and the connector is a small standing seam roof with visible rust/staining and repairs made with a membrane.

- 1. Steep-slope roof Roof Sections A and B.
 - a. Roof leaks at connector to Vestal Hall have been identified and repaired in recent years.

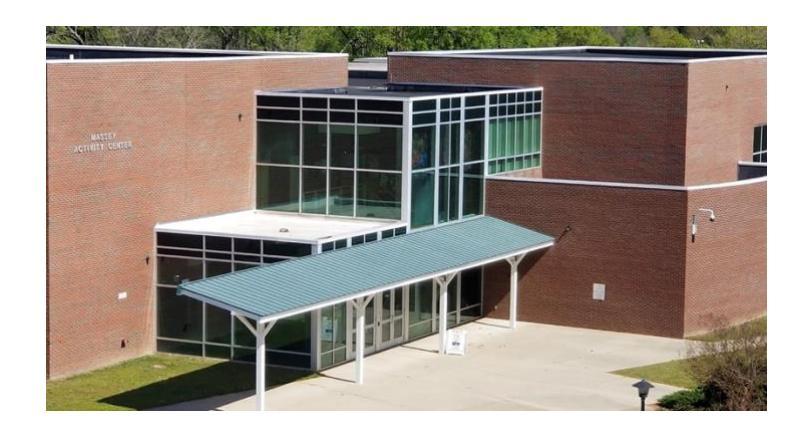
Massey Activity Center

A centrally located multipurpose building with a large storefront entrance and multiple roof levels. There are leaks in the storefront entrance system and/or the adjacent roof areas. Roofing membranes are mechanically attached EPDM in overall fair condition. There are exhaust hood penetrations associated with a grease collection system over a cafeteria.

- 1. Low slope roof Roof Sections A, B, C, D, E, F, and G
 - a. Grease collector requiring maintenance
 - b. Open coping joints
 - b. Debris on roof
 - d. Deteriorated membrane seams and small hole in membrane (possibly bullet hole)

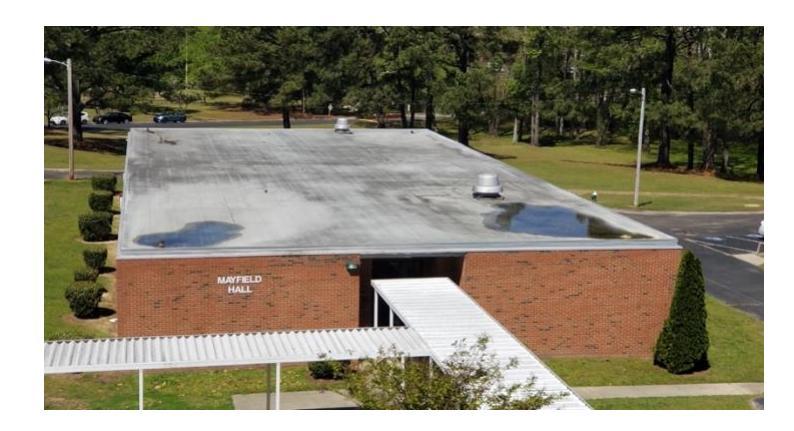
Mayfield Hall

This building is a single-story classroom building with a gravel stop and a modified bitumen roofing system in good condition, but does have blocked drains causing ponding issues and exhaust fans with low flashing heights.

- 1. Low slope roof Roof Sections A
 - a. Blocked drains/ponding
 - b. Low flashing heights

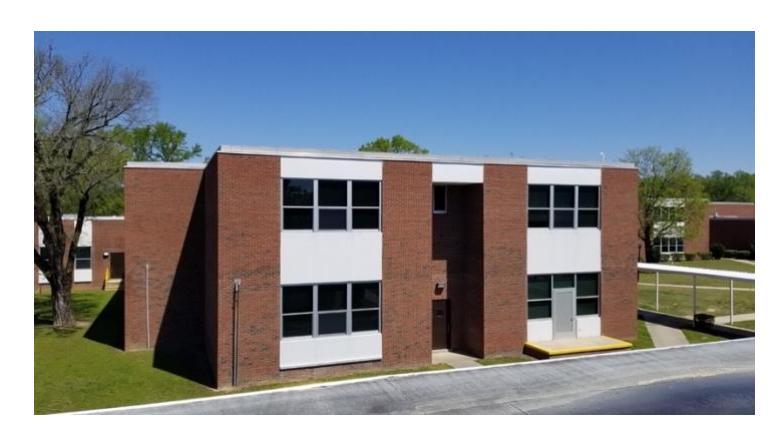
McAdams Building

This building is a combination two-story classroom building and athletic building. The athletic portion contains a gymnasium and abandoned indoor pool. A lower roof section provides a gym entry and administrative space. This lower roof has a fully adhered EPDM roof membrane. All other buildings have gravel surfaced built up membranes in overall fair condition.

- 1. Gravel surfaced low slope roofing Roof Sections A, B, C, D, E, F and G.
 - a. Minor ponding drain strainers blocked with excessive gravel
 - b. Loose metal coping cap
 - c. Crazed skylight domes
 - d. Cracked skylight domes containing water between the domes
- 2. EPDM membrane low slope roofing Roof Section H
 - a. Minor ponding and failed drain target flashing
 - b. Failed flashing at coping/building intersection
 - c. Debris on roof
 - d. Cracked masonry wall above gym and abandoned pool
 - e. Broken/missing louvers

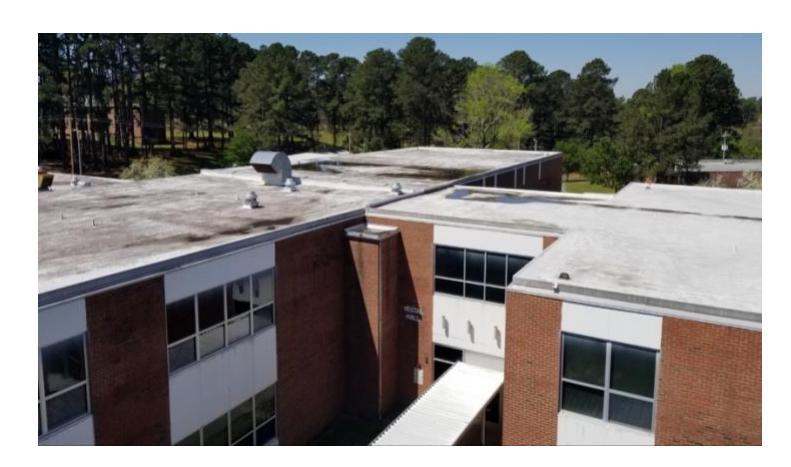
Vestal Hall

A two-story classroom building complex with interconnected building wings mainly low slope sections. The majority of the roofing sections appear to be gravel surface membranes where the gravel has been removed and the membrane has been coated. Small accessory roofs include connectors between buildings, a maintenance shed and a small structure that appears to be an added elevator shaft.

- 1. Low slope roof Roof Sections A, B, C, D, E, F, G and H
 - a. Blocked drains/ponding
 - b. Deteriorated coating
 - c. Small elevator shaft membrane roof loose, wrinkled

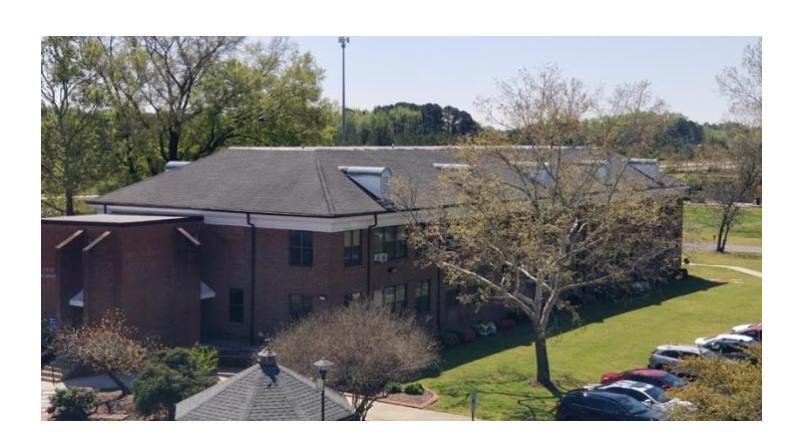
Woodard Hall

This administrative building has steep-sloped hip roofs with asphalt shingles and a low-slope section, entrance and accessory roofs that have modified bitumen. Roofing systems are in good condition.

- 1. Low slope roof Roof Sections A, C and D
- 2. Steep-slope roof Roof Section B
